Manhole Inspection Summary

Manhole # S53O__018MH

Insp Date: **12/23/08 12:14 PM**

Location Address: **rear 1102 s clinton st**

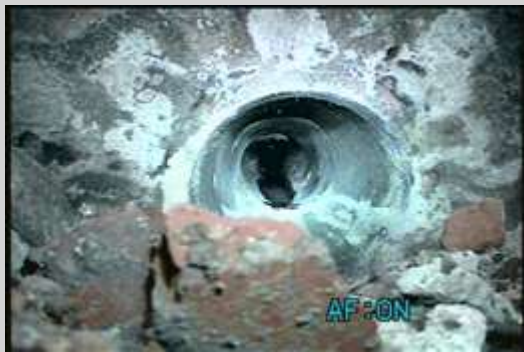
12 O'Clock Outflow

8 in. Circular Gravity Sewer
Pipe Out @ 12 O'Clock

Pipe Material: **Clay** ☐ Pipe Lined

Infiltration: **None** Pipe Seal Cond: **Unknown**
